# Avid Pro Tools Software v2026.4

## ReadMe for Windows

This ReadMe documents important compatibility information and known issues for all tiers of Pro Tools® software, version 2026.4 on Windows 11 (24H2 and 25H2).

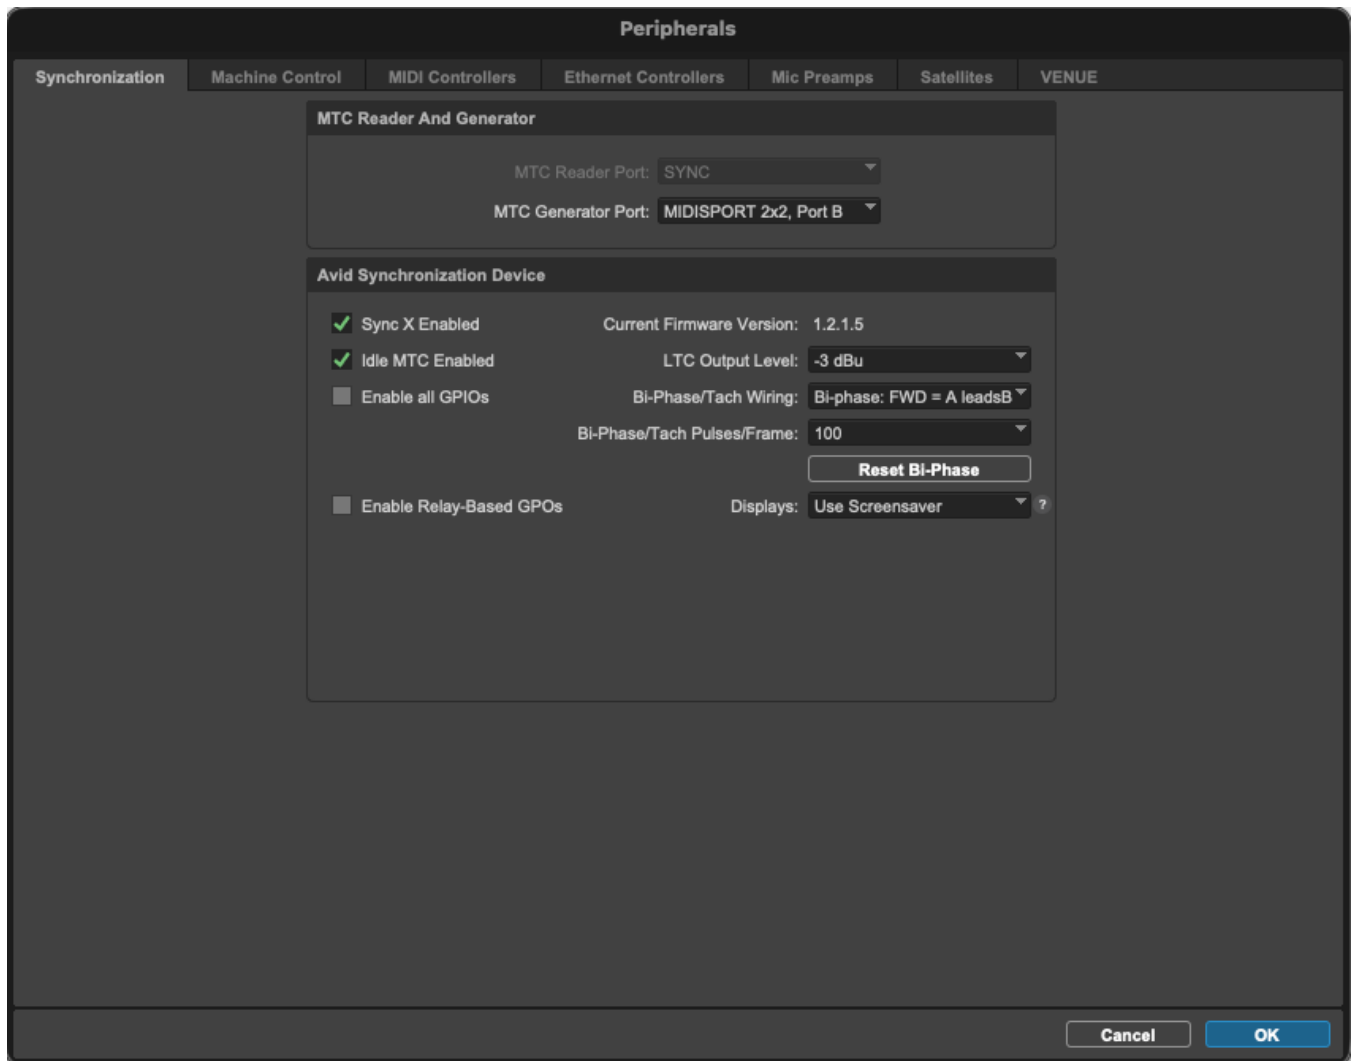
The **Enable all GPIOs** option in the **Synchronization** page of the Peripherals dialog (**Settings > Peripherals > Synchronization**) completely disables (default state) or enables the GPIO for Sync HD and Sync X.

💡 In previous versions of Pro Tools, the GPIO was always enabled. Disabling the Enable All GPIOs option alleviates -22003 errors that can occur when time sensitive Synchronization/GPIO packets are sent (regardless of whether or not you are using Relay Based GPIO).

If you are using the GPIO to trigger or as a trigger, ensure that the **Enable all GPIOs** and **Enable Relay-Based GPOs** options are enabled.
